Technical Report No. 32-978

*An Experimental Evaluation of 100-lb-Thrust
Ablatively Cooled Rocket Engines*

*W. H. Tyler
R. N. Porter*

JET PROPULSION LABORATORY
CALIFORNIA INSTITUTE OF TECHNOLOGY
PASADENA, CALIFORNIA

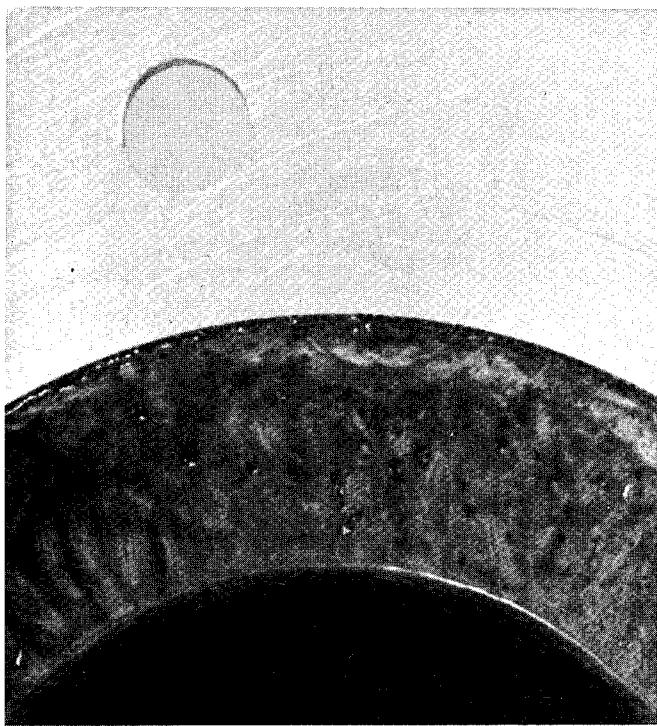
The technique and materials used to fabricate this chamber assembly apparently caused the formation of resin-rich and resin-starved areas. Upon curing, this improper distribution of the resin resulted in the formation of voids or pores. Figure 6 is a close-up view of a portion of the rear surface of the chamber where some of these pores intersect the external surface.

Fig. 6. Local pores and voids in the Aerojet-General ablative chamber (before firing test)

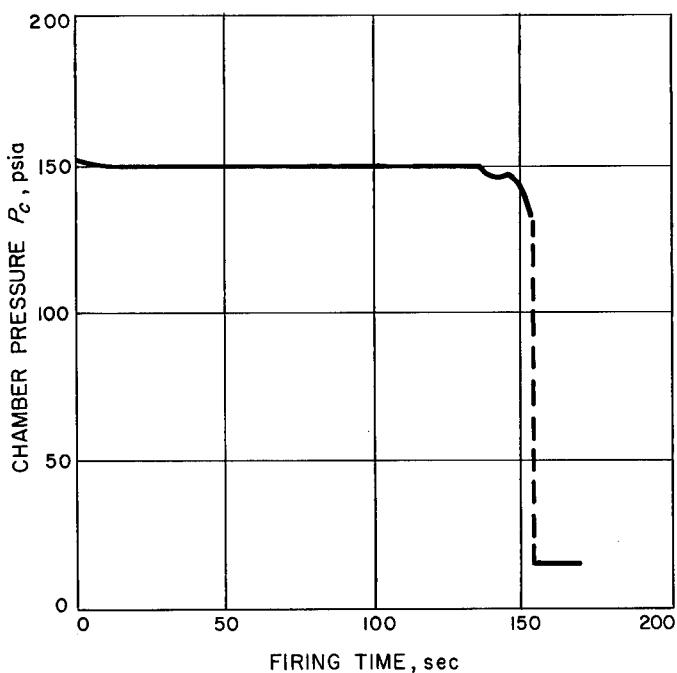
As shown in Fig. 12, chamber pressure in the AGC chamber stabilized at about 150 psia within 20 sec, followed by a decrease of only 2 psi during the next 110 sec of testing. At 132 sec the chamber pressure began to decrease rapidly until the test was terminated at 153 sec when it was believed that the chamber throat had failed. Postrun inspection of the chamber showed that the throat insert was in reasonably good shape despite the fact that a portion in the forward side was broken off. At least three good-sized holes were found around the outside of the throat insert and these were apparently the main cause of chamber-pressure loss. Figure 13 shows the change in the nozzle throat as a result of the firing.

Fig. 12. Record of chamber pressure during the firing test of the Aerojet-General ablative chamber

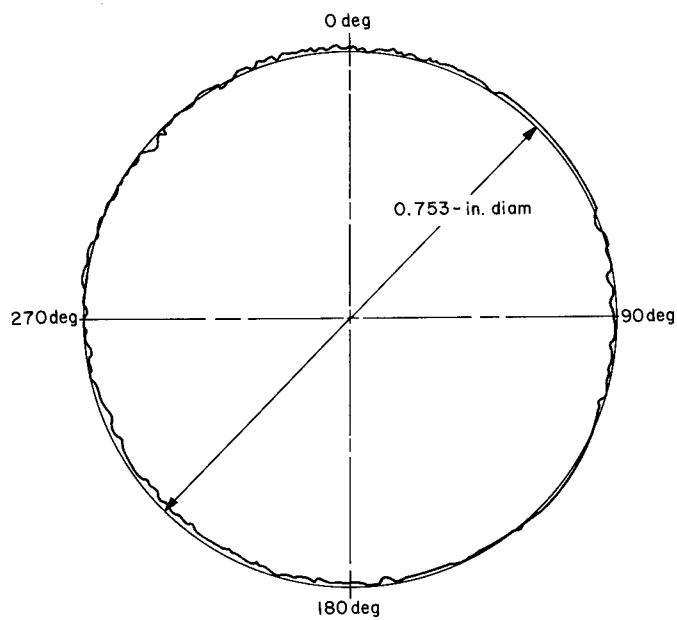
Fig. 13. Nozzle-throat area in Aerojet-General ablative chamber, before and after the firing test

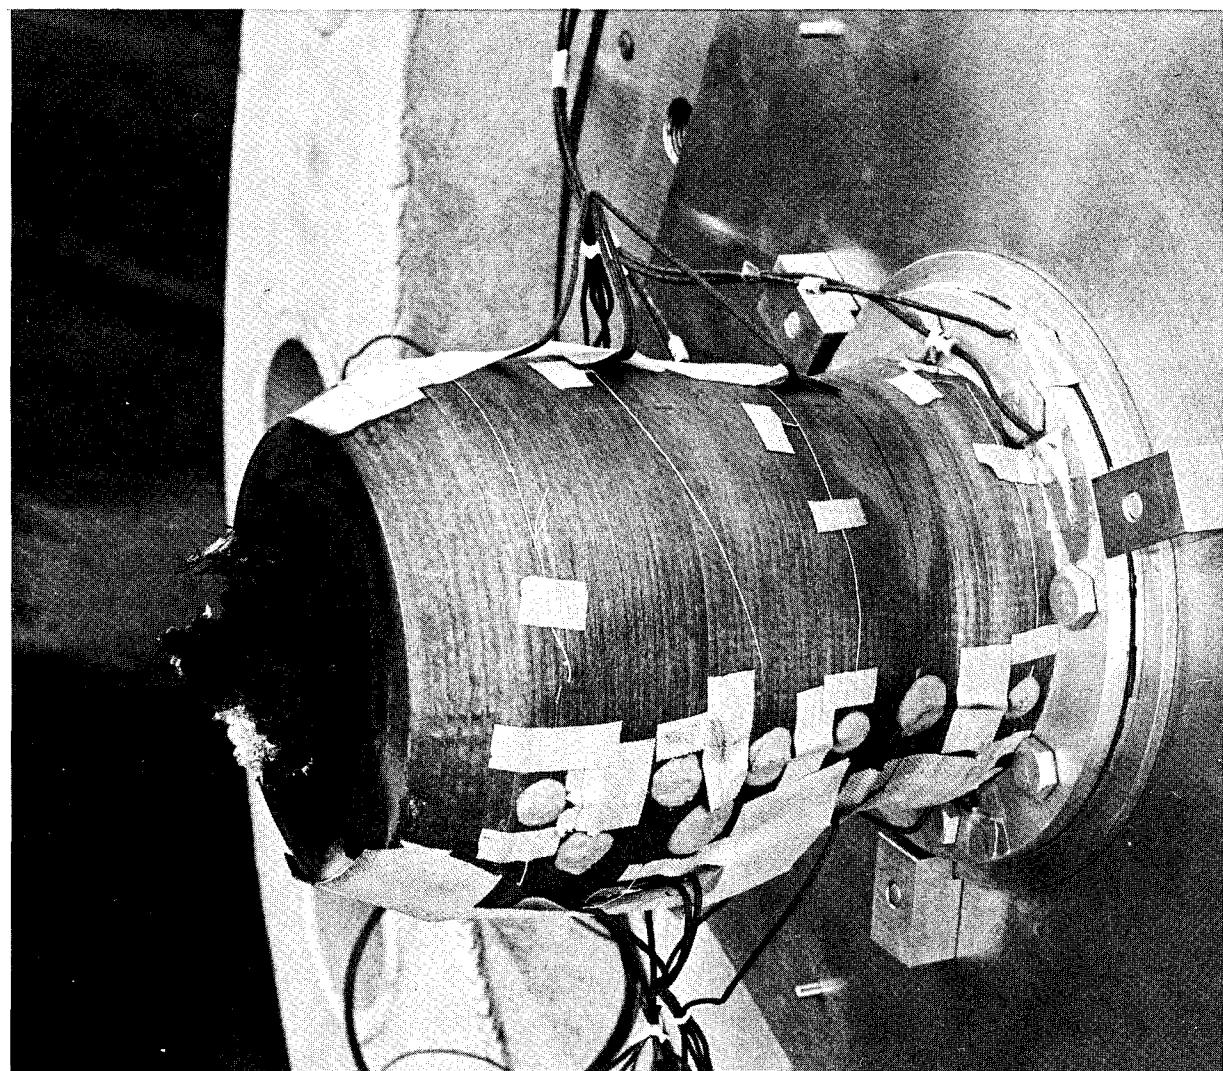
Fig. 15. External view of Aerojet-General ablative chamber after the firing test, showing the local hot spot and wall separation

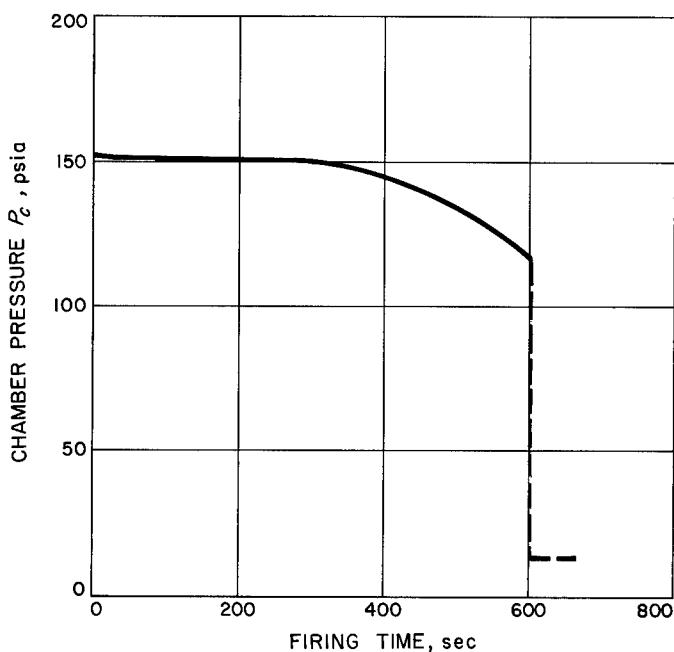
The AVCO chamber ran for about 4½ min with little or no change in chamber pressure (Fig. 16). The chamber pressure stabilized at 152 psia after about 50 sec and remained constant for 263 sec followed by a decline to 117 psia at the termination of the test at 600 sec.

Fig. 16. Record of chamber pressure during the firing test of the AVCO ablative chamber

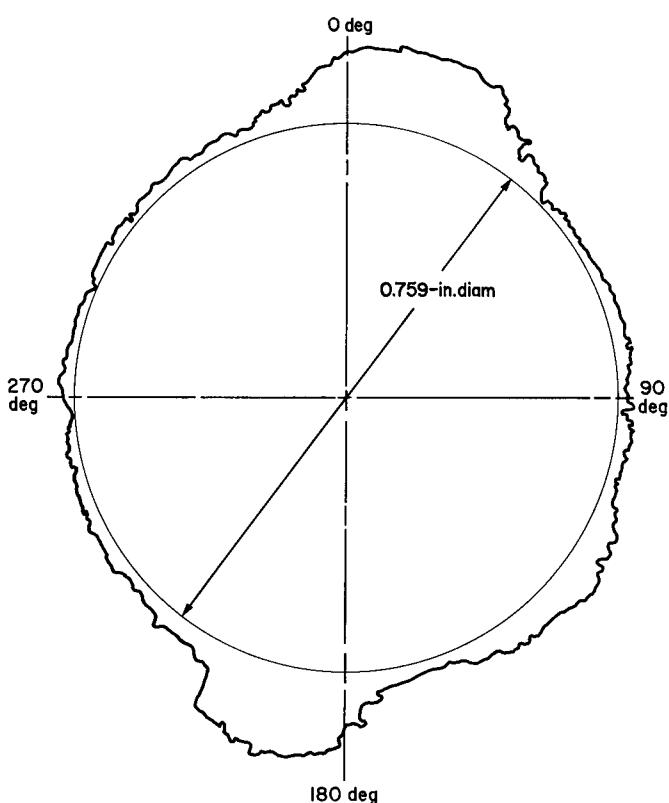
Fig. 17. Nozzle-throat area in AVCO ablative chamber, before and after the firing test

of hot-gas leaks around the throat-insert assembly (washers). Figure 17 shows the nozzle-throat outline before and after the test.

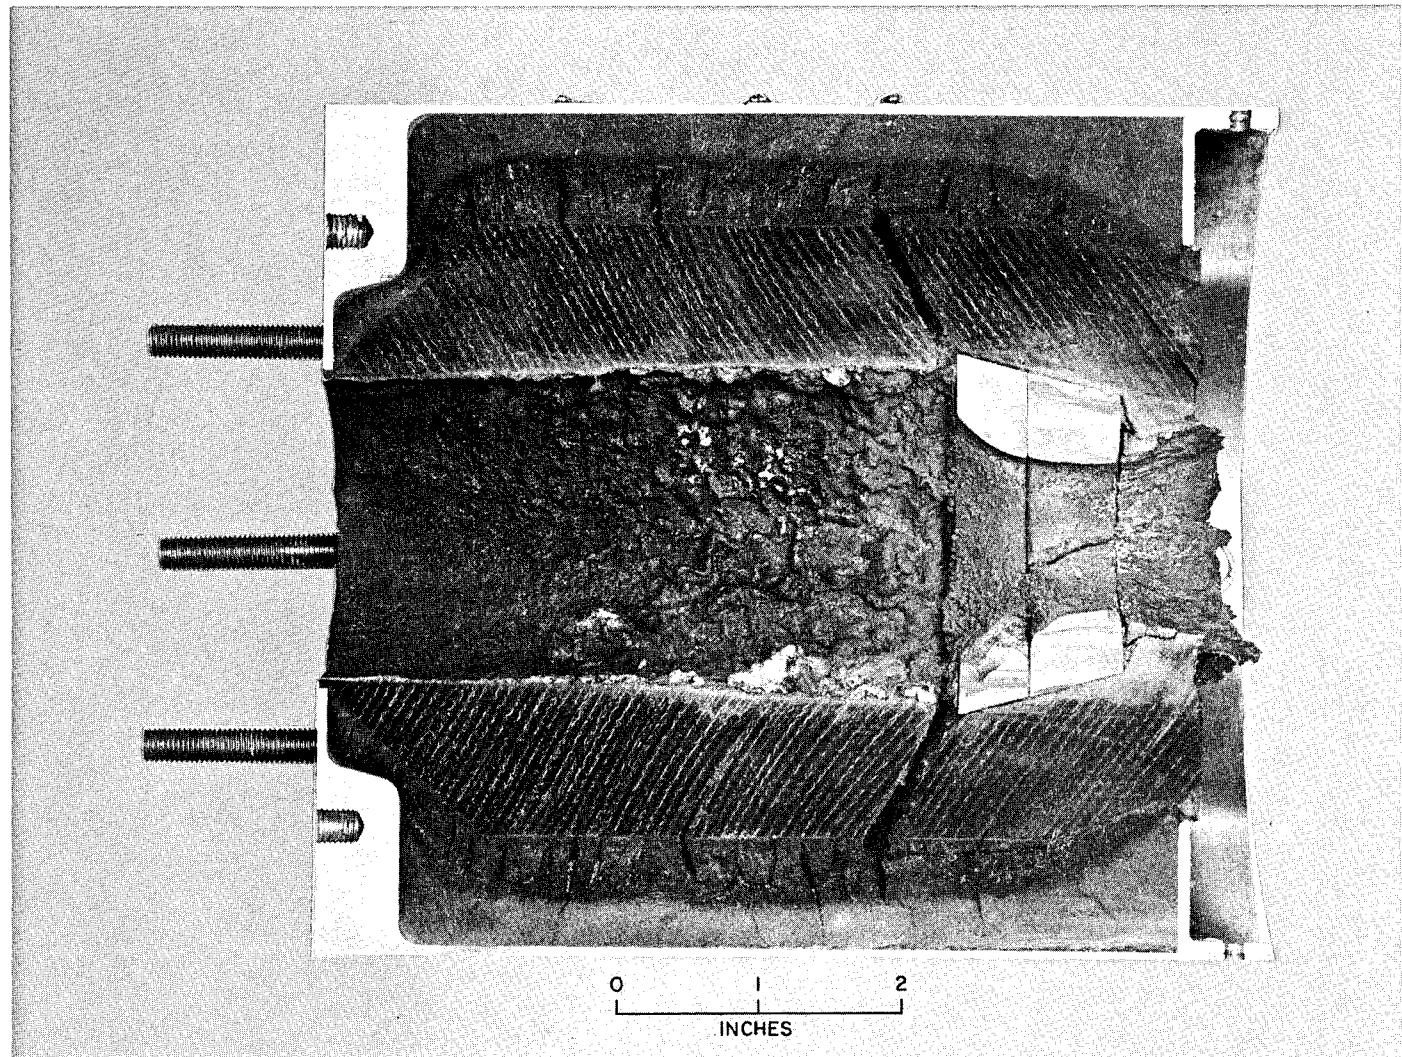
After the chamber was sectioned, the throat inserts were found to be cracked in several places, with one badly eroded area between the two insert washers. Figure 18 is a view of a section of the chamber.

Inspection of the sectioned chamber assembly (Fig. 18) reveals severe cracks and voids in the thermal insulator and ablative chamber liner. An appreciable rearward shift of the throat-insert and ablative-wall assembly caused a very large crack in the ablative material just forward of the throat insert.

Fig. 18. Cross section of AVCO ablative chamber after firing test, showing the cracked nozzle-throat insert and char depth

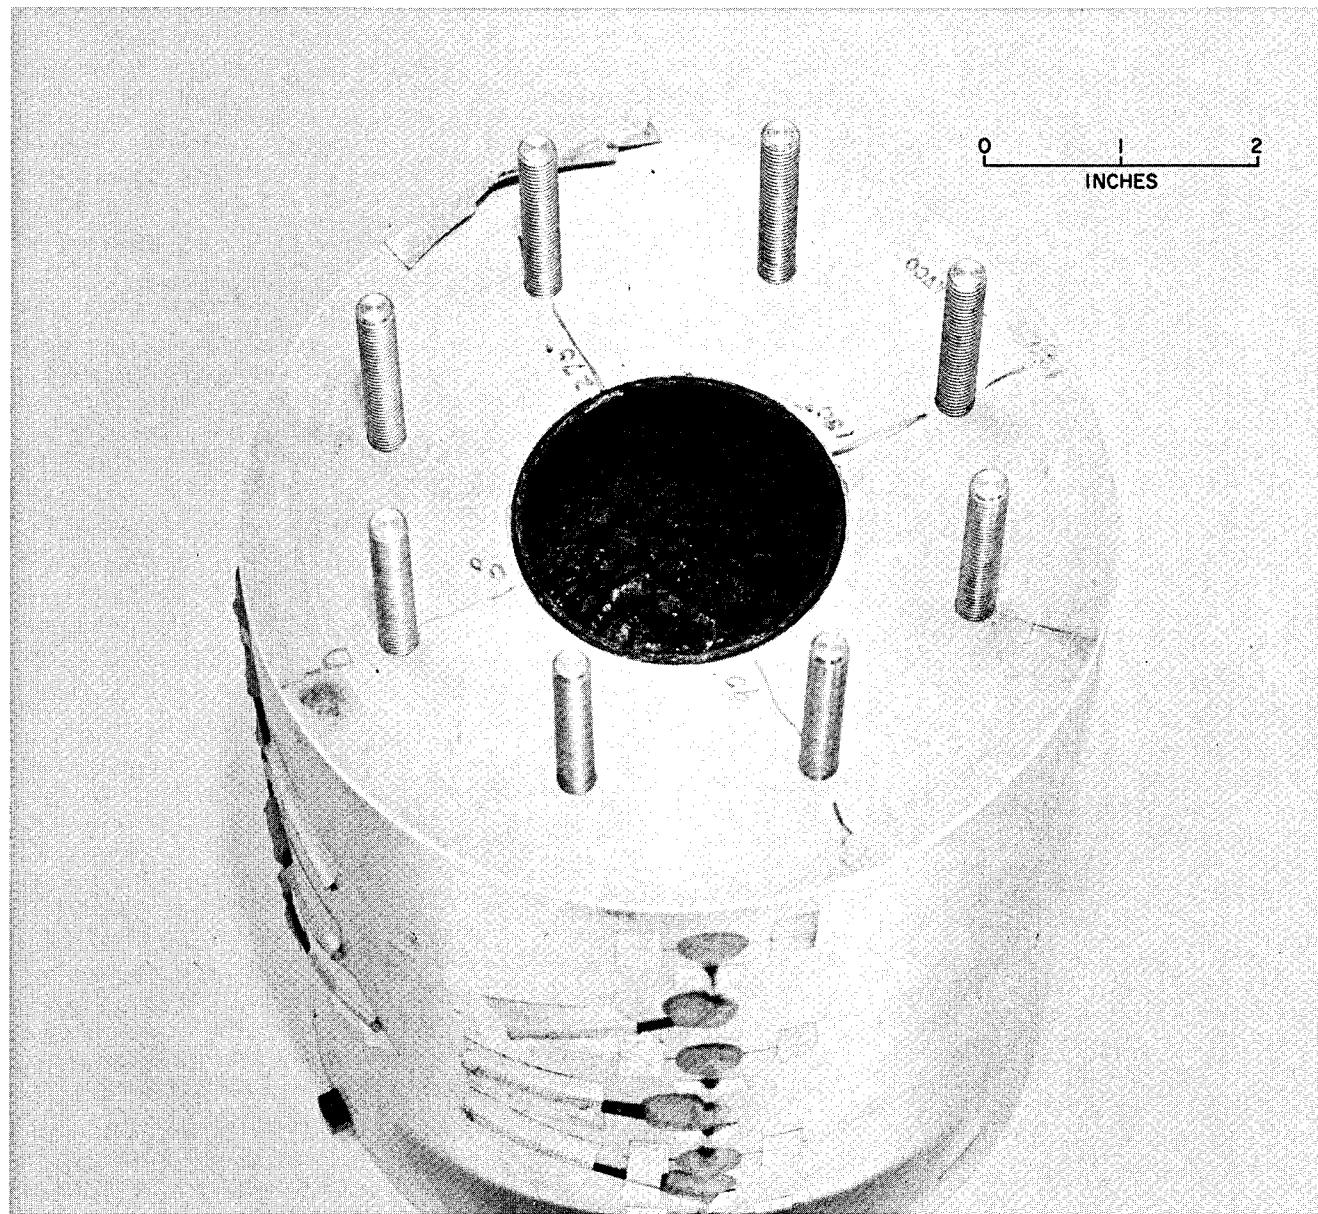
Fig. 19. Oblique view into AVCO ablative chamber, showing a localized region of intense erosion

The ablative liner had a very liquid-appearing surface (i.e., an appearance similar to water on an oiled surface), with considerable material washed down toward the insert assembly. There was also a deposit buildup on the surface of the insert downstream of washed-out areas of the chamber.

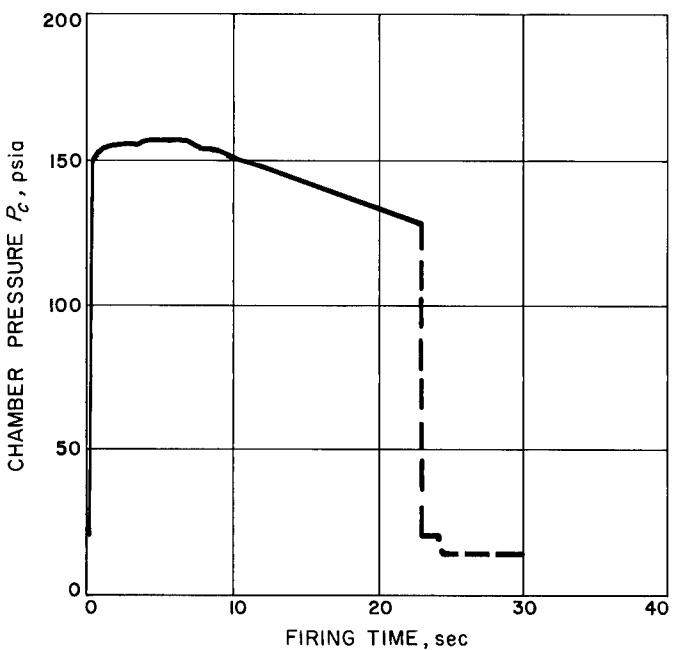
The chamber pressure was stabilized for only a few seconds at 156 psia before it started to decrease to a value of 128 psia at the time the thrust chamber failed. The chamber-pressure decay was nearly straight-line and up to the time of chamber failure, it had declined over 18% for the 23 sec of test time. Figure 20 is a plot of the chamber pressure vs time.

Fig. 20. Record of chamber pressure during the firing test of the HITCO ablative chamber

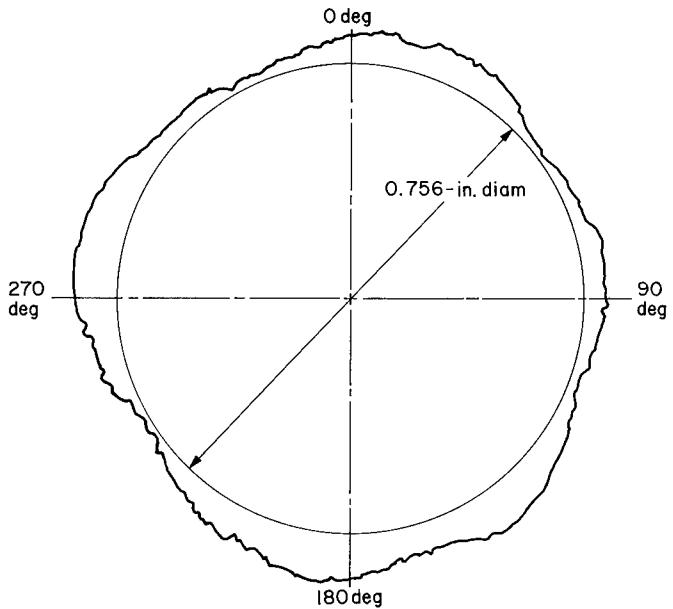
Comparison of the throat area before and after the firing test (Fig. 21) showed a total throat-area increase of 22% or nearly a 1% increase per second of test time. Extrapolation of the chamber-pressure decay indicated that without the structural failure of the chamber, the test would probably have been terminated after about 30 sec total duration when the pressure would have reached 120 psia.

Fig. 21. Nozzle-throat area in HITCO ablative chamber, before and after the firing test

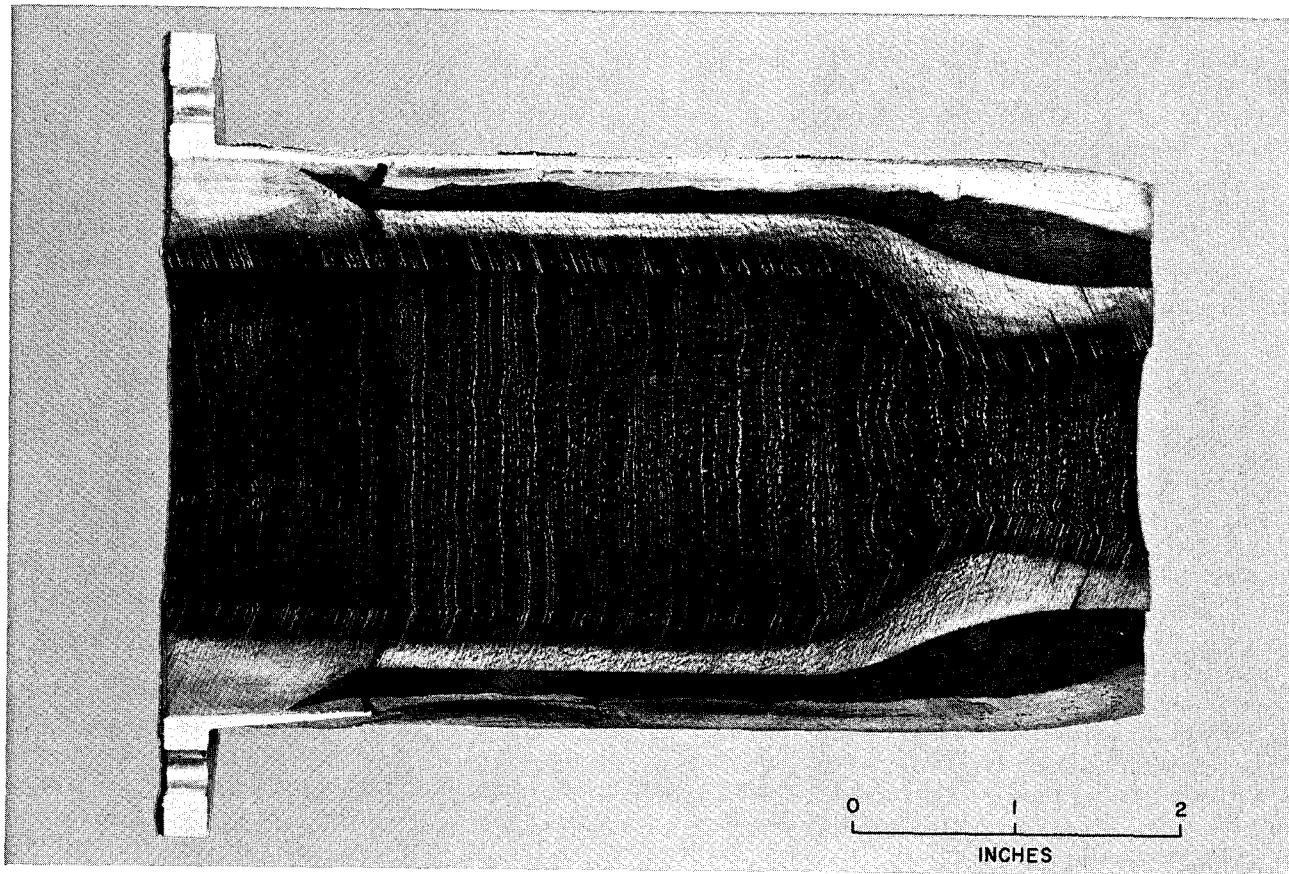
Fig. 22. Cross section of HITCO ablative chamber, showing the area of separation

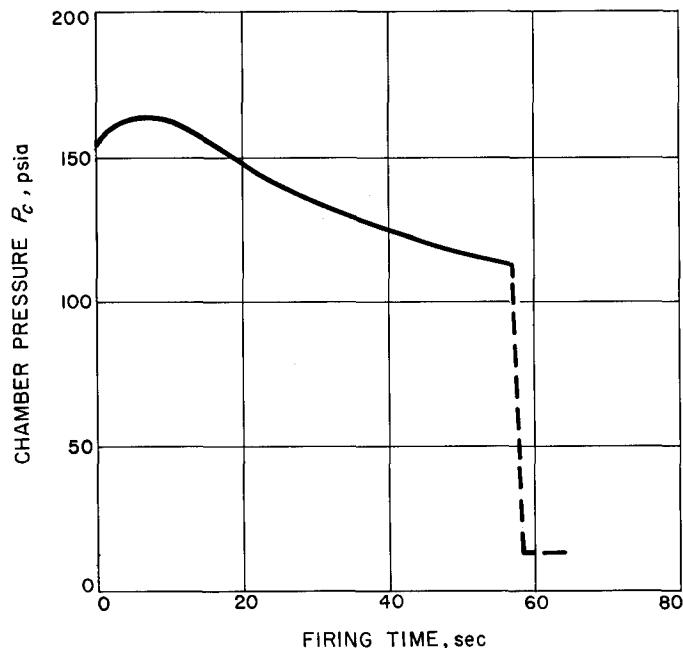
The throat apparently had an initial shrinkage followed by a fairly rapid enlargement. The chamber pressure record (Fig. 23) shows an initial pressure rise to a value of 164 psia (nearly 10% higher than anticipated), followed by a continuous decrease to 113 psia at the end of the test.

Fig. 23. Record of chamber pressure during the firing test of the MAP ablative chamber

During the 57-sec test, there was a total throat-area increase of 41%. Total weight loss was over 6%, which when compared on a test-duration basis, is the highest weight-loss rate of the five chambers tested.

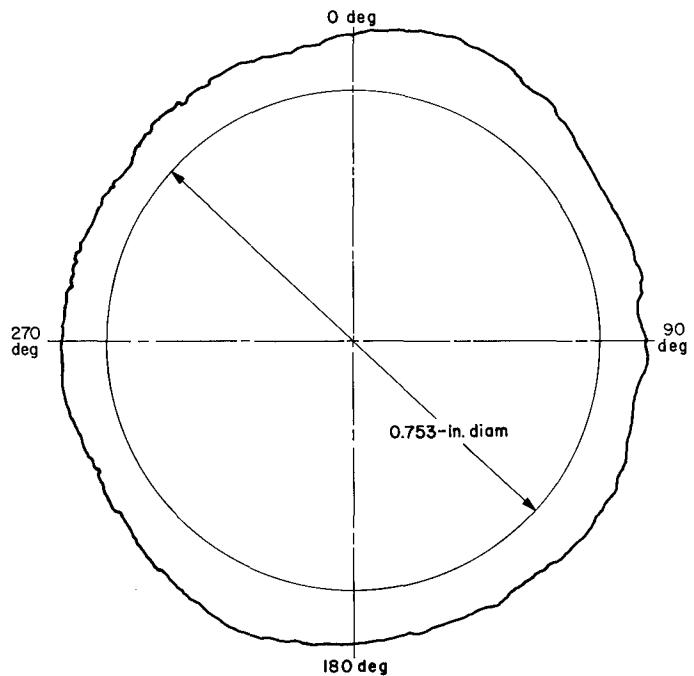
The erosion pattern of the throat, shown in Fig. 24, was fairly uniform with only two areas slightly more eroded than the average. The erosion of the chamber section was not so uniform. The sectional view in Fig. 25 shows that the majority of the material loss occurred starting approximately 1½ in. downstream of the injector with "islands" of material separating rather large and deep channels where much material was lost.

Fig. 24. Nozzle-throat area in MAP ablative chamber, before and after the firing test

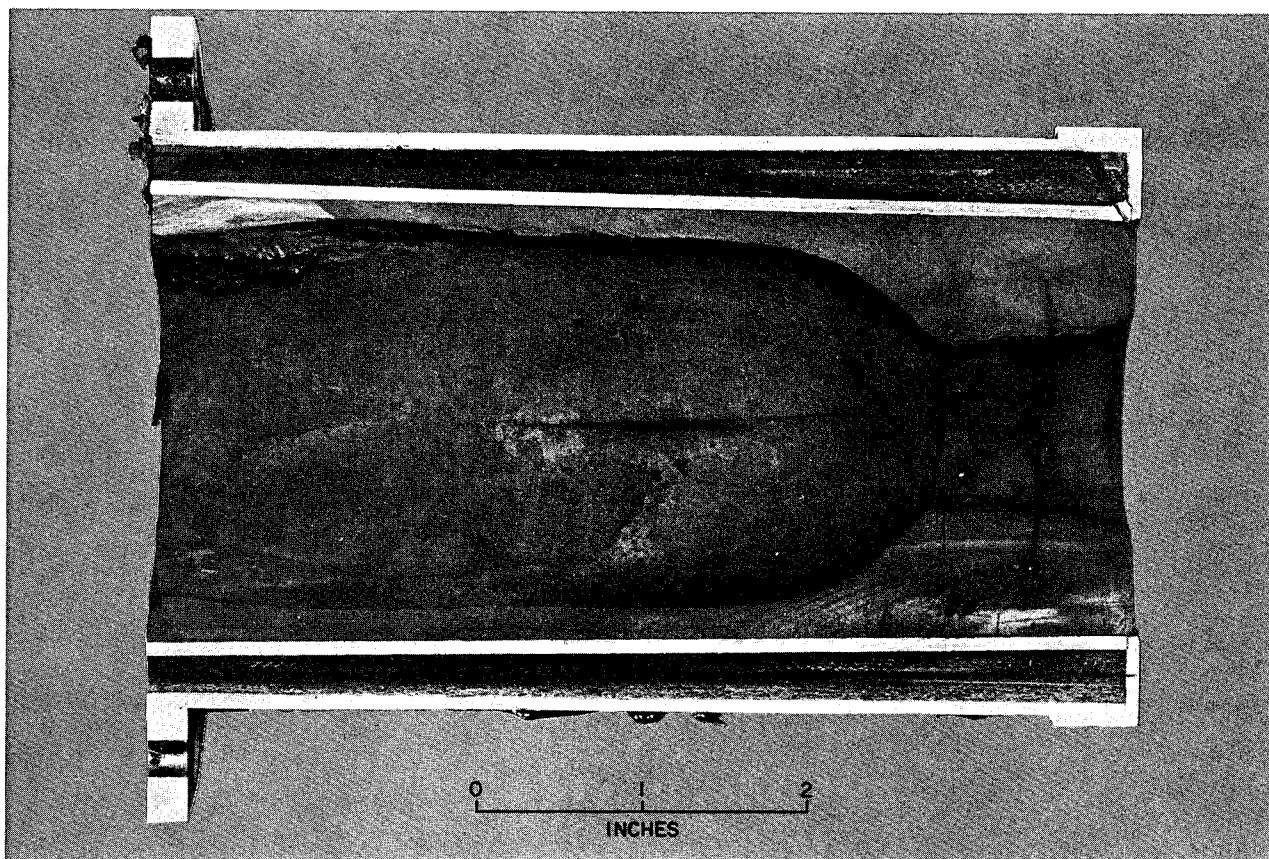
The sectioned chamber (Fig. 25) also revealed local cracking and separation of the ablative liner. The liner had two large cracks (traverse to the axis of the chamber) on each side of the throat and there were many small cracks, particularly along the surface of the molybdenum retainer sleeve.

This chamber design is judged to be unsatisfactory for several reasons; two in particular are: (1) the choice of material for the ablative liner, which was the same for both the chamber and the throat, was poor, as evidenced by severe erosion in both areas, and (2) there seems to be an insufficient amount of thermal insulation between the ablative liner assembly and the outer structural shell to give effective temperature control.

Fig. 25. Cross section of MAP ablative chamber after the firing test

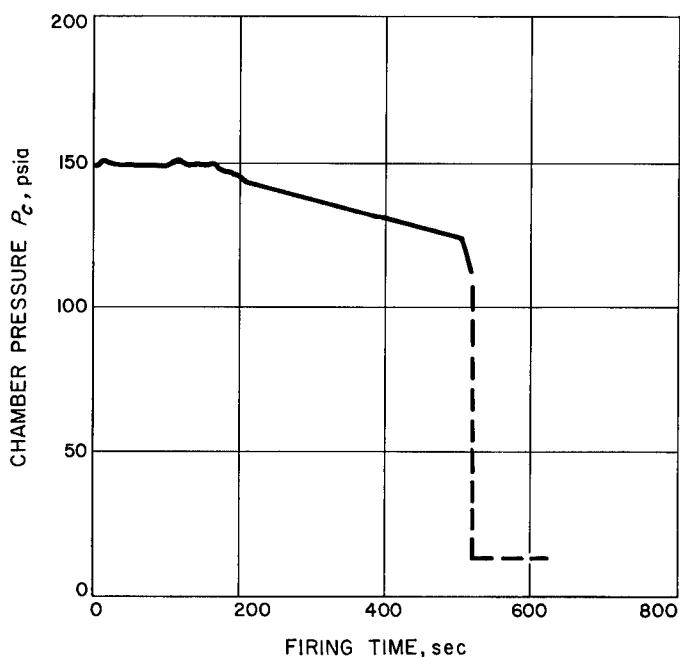
Failure (burn through) of the throat insert, with the associated loss of chamber pressure, caused the termination of the test of the TRW ablative thrust chamber. As can be seen in Fig. 26, the chamber pressure stabilized at 150 psia and remained essentially unchanged for 160 sec. At this time, erosion of the throat insert began and the chamber pressure continually decreased until it reached 124 psia after 508 sec, when the throat insert completely failed (burned through). After this, the chamber pressure dropped to 112 psia at 520 sec, at which time the firing was stopped. The throat area was found to have increased a little over 19% during the test; Fig. 27 is a diagram of the nozzle-throat area before and after the firing.

The axial thrust remained essentially constant for the first 270 sec of the test despite the loss of chamber pressure, which started around 160 sec. Until 270 sec had elapsed, the indicated thrust decrease was only 1½%. By the end of the test, axial thrust had decreased 3.6% from the initial value.

Fig. 26. Record of chamber pressure during the firing test of the TRW ablative chamber

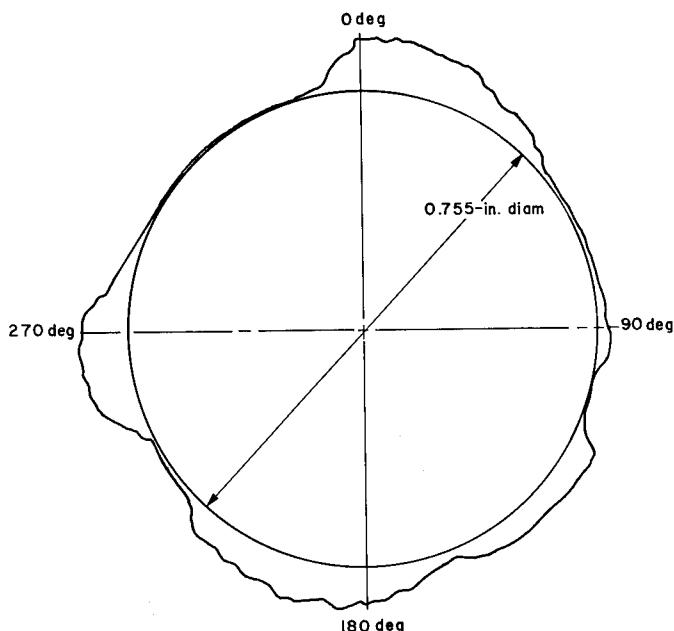
Fig. 27. Nozzle-throat area in TRW ablative chamber, before and after the firing test

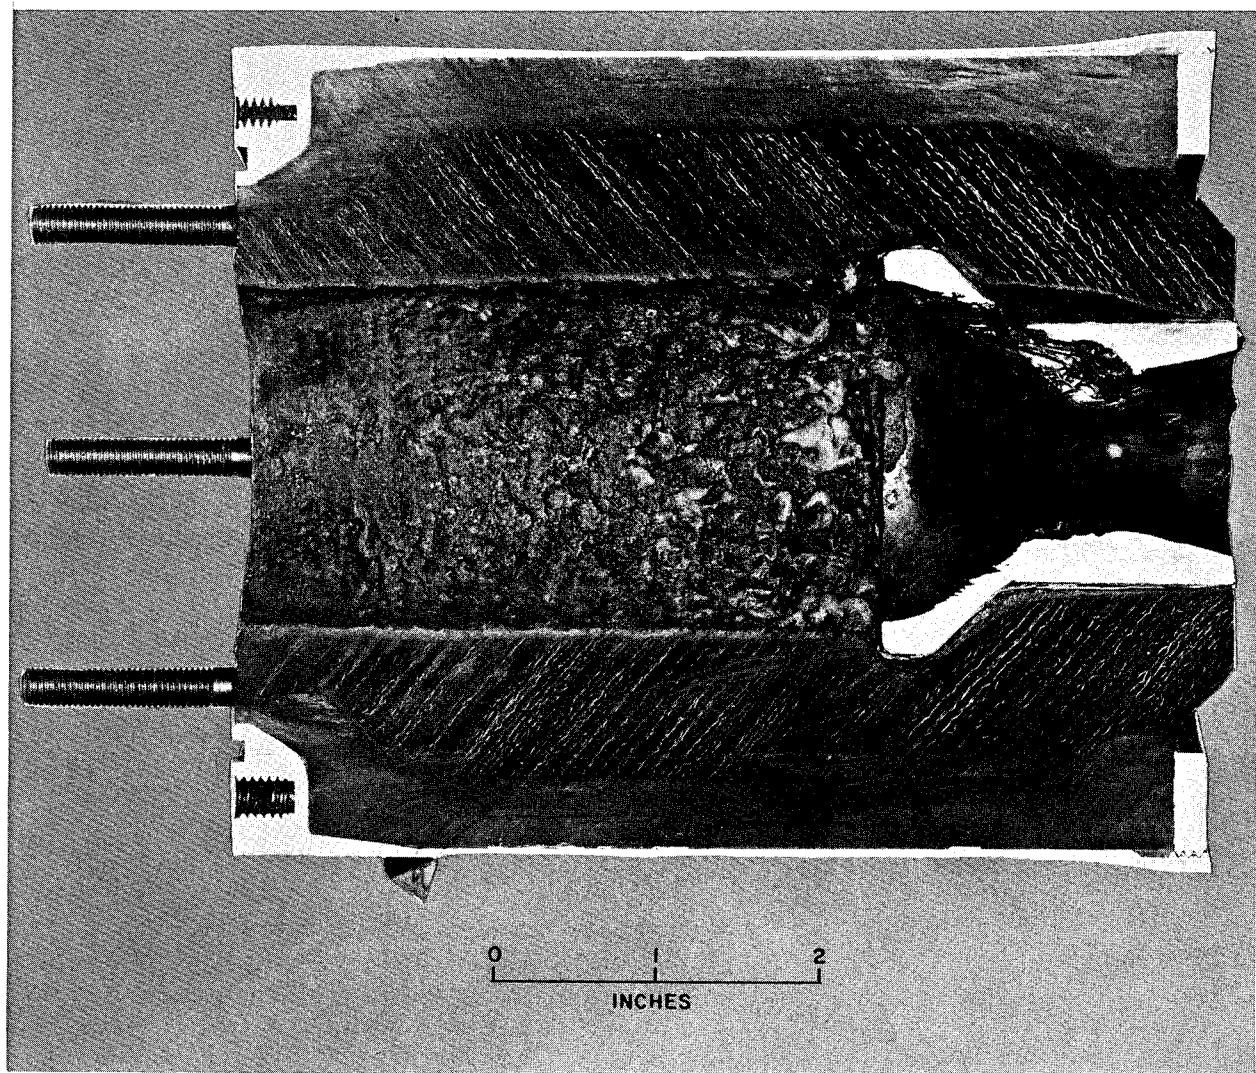
In general, the TRW chamber appeared to be a good design; its two weak points were the throat insert and the radial heat path of the metal mounting flange. (The latter shortcoming was almost intrinsic in the specification requirements calling out the flange dimensions and all of the chamber designs were weak to a degree from this fault.) The appearance of this chamber after firing, with the exception of the throat insert, was quite good and the ablative liner was probably in the best condition of any of the chambers tested.

Fig. 28. Cross section of TRW ablative chamber after firing test, showing the undermining of the nozzle insert
